# Intel<sup>®</sup> Xeon<sup>®</sup> Processor E3-1200 v5 Product Family

Specification Update

*Revision 017*

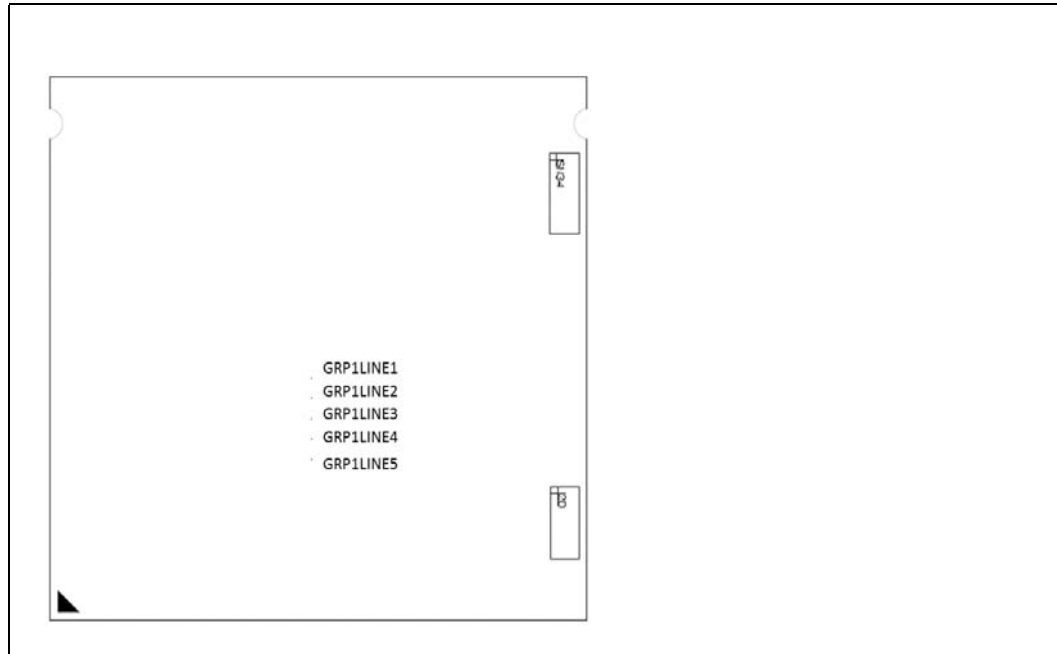
The processor stepping can be identified by the following component markings.

Figure 1. Intel® Xeon® Processor E3-1200 v5 Product Family LGA Top-Side Markings

Pin Count: 1151

Package Size: 37.5 mm x 37.5 mm
