Intel[®] 5 Series Chipset and Intel[®] 3400 Series Chipset

Specification Update

| Document Number: 322170-017

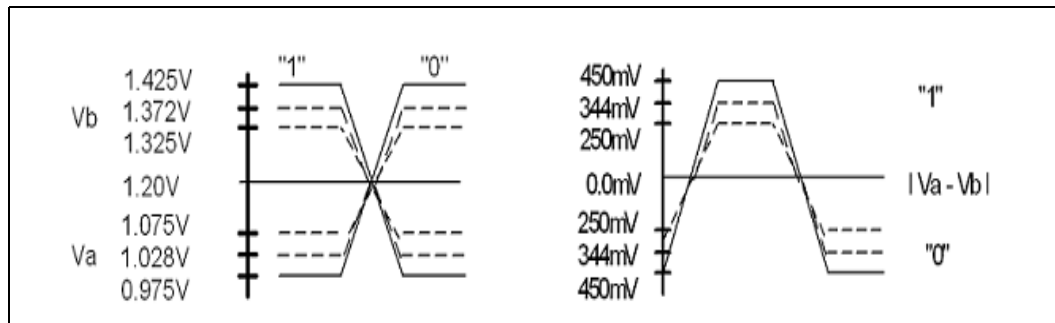
Figure 5-15. LVDS Signals and Swing Voltage

Figure 5-15 shows a pair of LVDS signals and swing voltage.

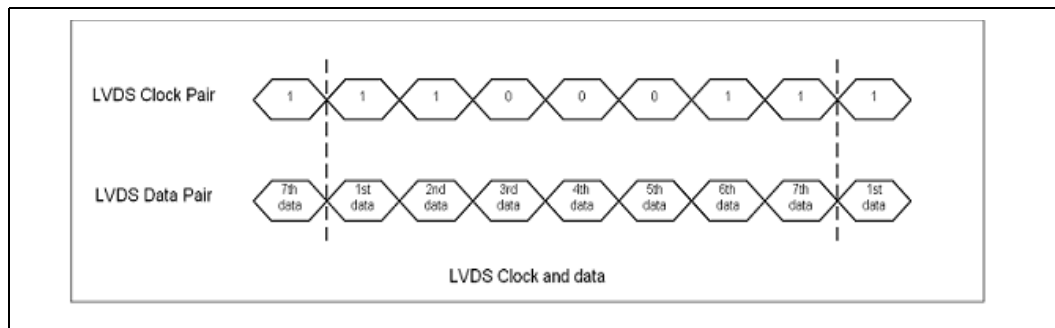
Figure 5-16. LVDS Clock and Data Relationship

Logic values of 1s and 0s are represented by the differential voltage between the pair of signals. As shown in the Figure 5-16 a serial pattern of 1100011 represents one cycle of the clock.

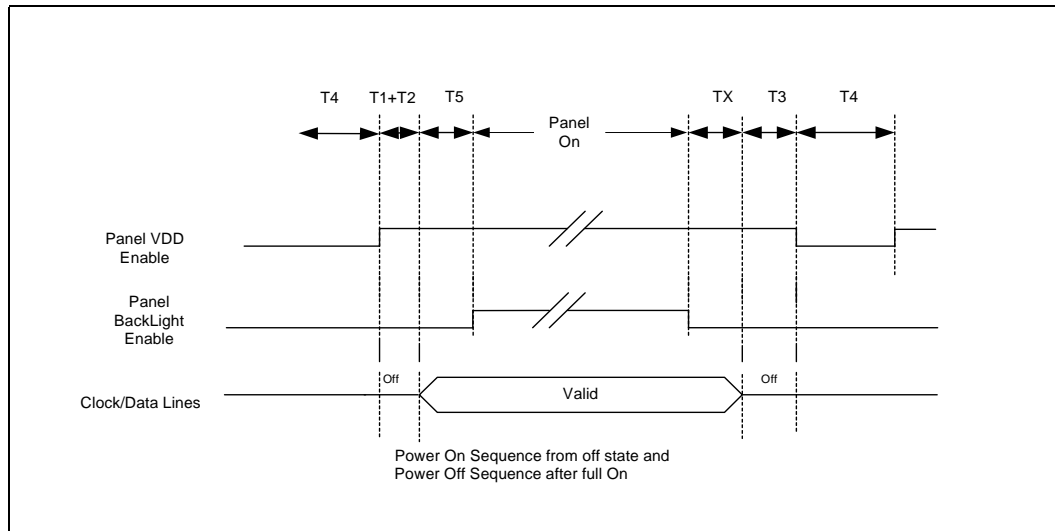
Figure 5-17. Panel Power Sequencing

A defined power sequence is recommended when enabling the panel or disabling the panel. The set of timing parameters can vary from panel to panel vendor, provided that they stay within a predefined range of values. The panel VDD power, the backlight on/off state and the LVDS clock and data lines are all managed by an internal power sequencer.

NOTE: Support for programming parameters TX and T1 through T5 using software is provided.

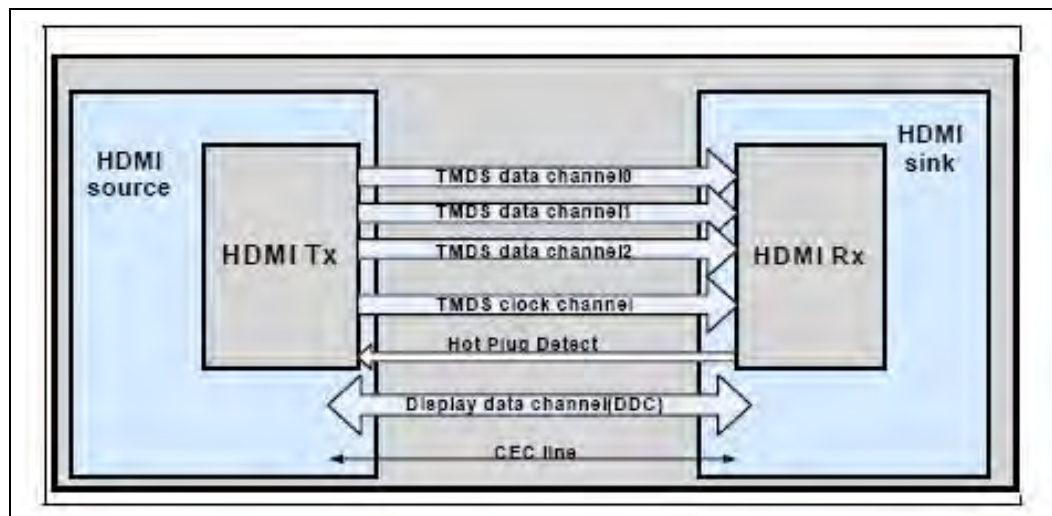
Figure 5-18. HDMI Overview

HDMI includes three separate communications channels: TMDS, DDC, and the optional CEC (consumer electronics control) (not supported by the PCH). As shown in Figure 5-18, the HDMI cable carries four differential pairs that make up the TMDS data and clock channels. These channels are used to carry video, audio, and auxiliary data. In addition, HDMI carries a VESA DDC. The DDC is used by an HDMI Source to determine the capabilities and characteristics of the Sink.

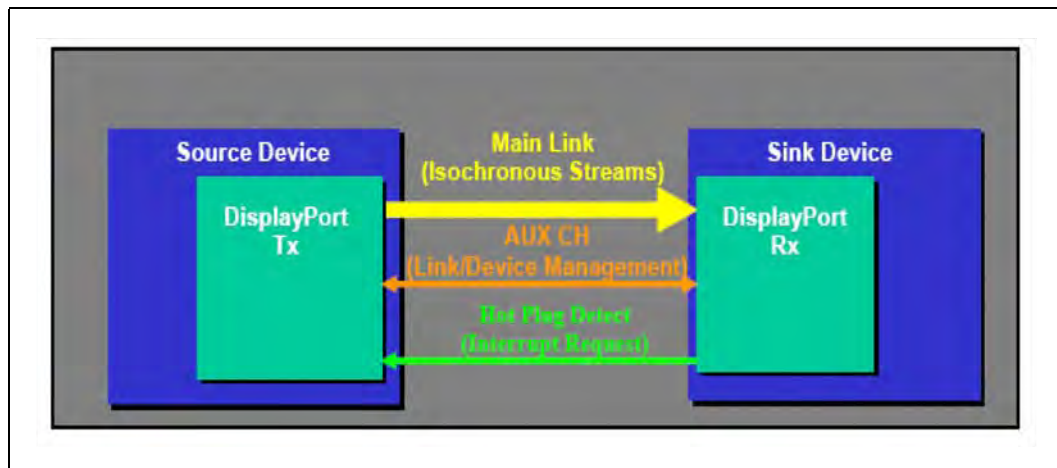
Figure 5-19. DisplayPort Overview

PCH is designed as per VESA DisplayPort Standard Version 1.1a. The PCH supports VESA DisplayPort* PHY Compliance Test Specification 1.1 and VESA DisplayPort* Link Layer Compliance Test Specification 1.1.

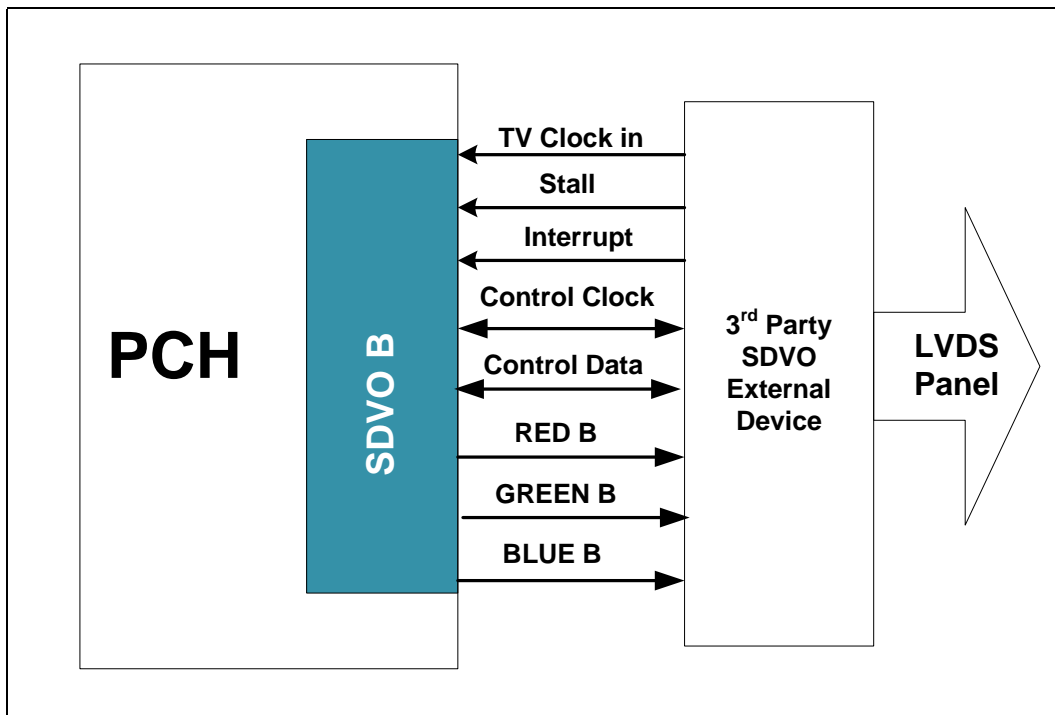
Figure 5-20. SDVO Conceptual Block Diagram

SDVO is supported only on Digital Port B of the PCH.

Communication to SDVO registers and if utilized, ADD2 PROMs and monitor DDCs, are accomplished by using the SDVOCTRLDATA and SDVOCTRLCLK signals through the SDVO device. These signals run up to **400 kHz** and connect directly to the SDVO device.
